## Technical Evaluation of the Gold King Mine Incident

San Juan County, Colorado

October 2015

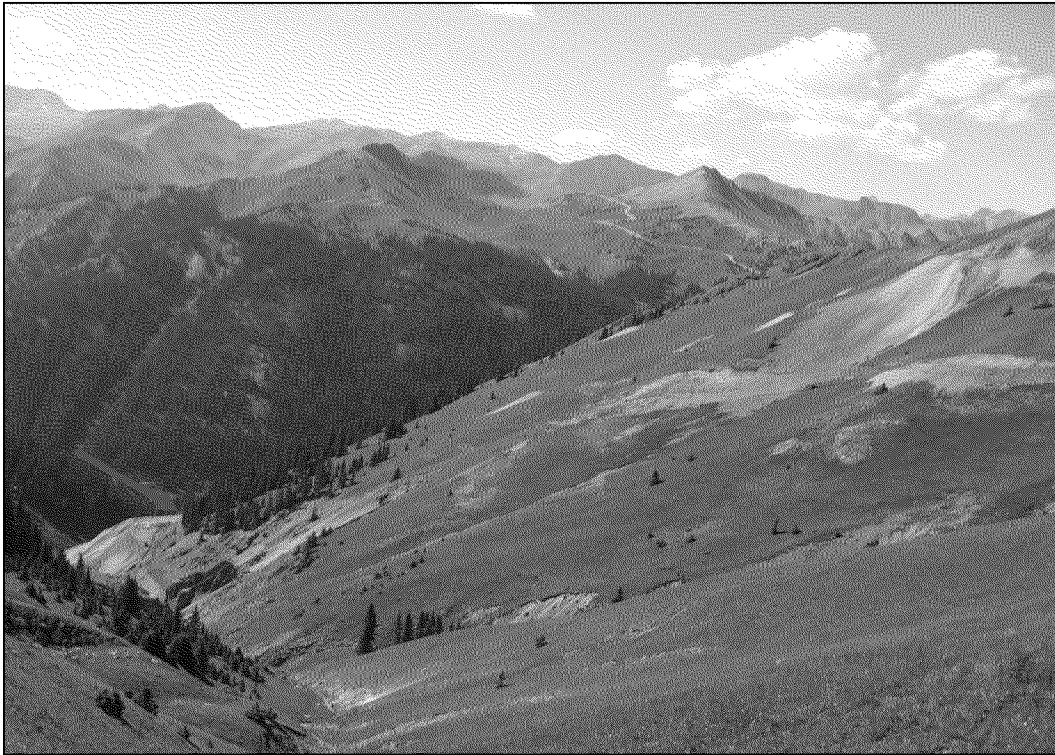
Figure 1.—Photograph of the Gold King Mine looking west. The red arrow points to the location of the mine blowout, which occurred on August 5, 2015.

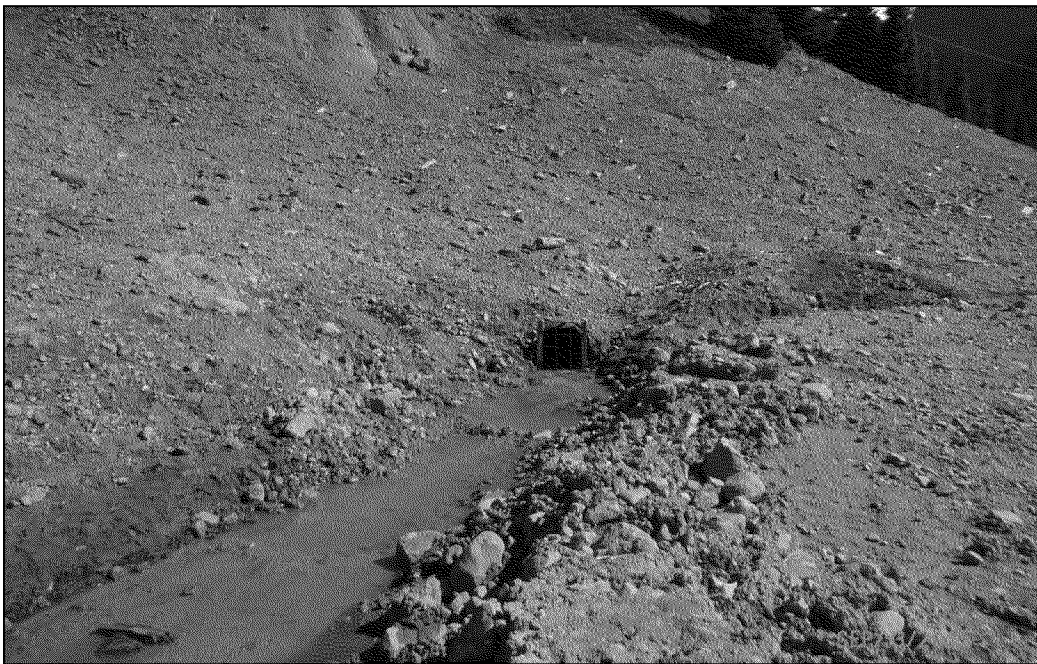
Figure 7.—Photograph showing the seepage outflow from the drain pipe at the American Tunnel at Gladstone, Colorado, as it appeared on September 3, 2015, with about 100 gpm of acid water flowing out.

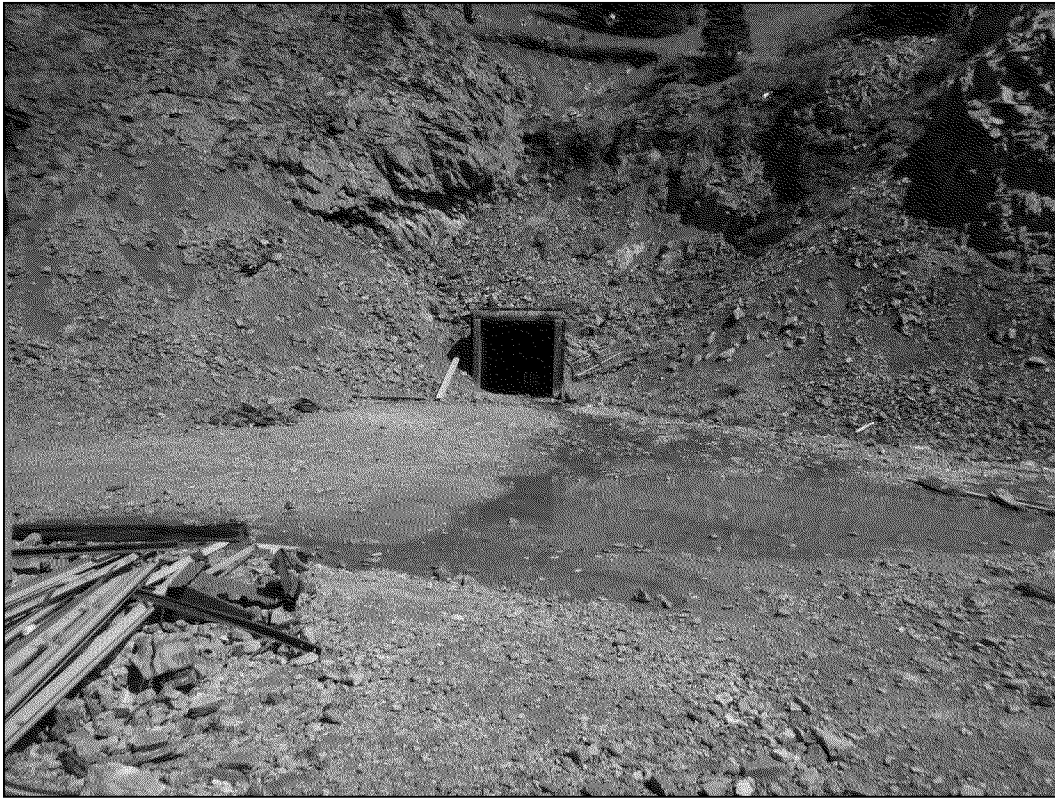
Figure 10.—Photograph showing seepage from the Mogul Mine on September 15, 2015. This mine has hydraulic bulkheads to limit the outflow of water from the Sunnyside Mine.

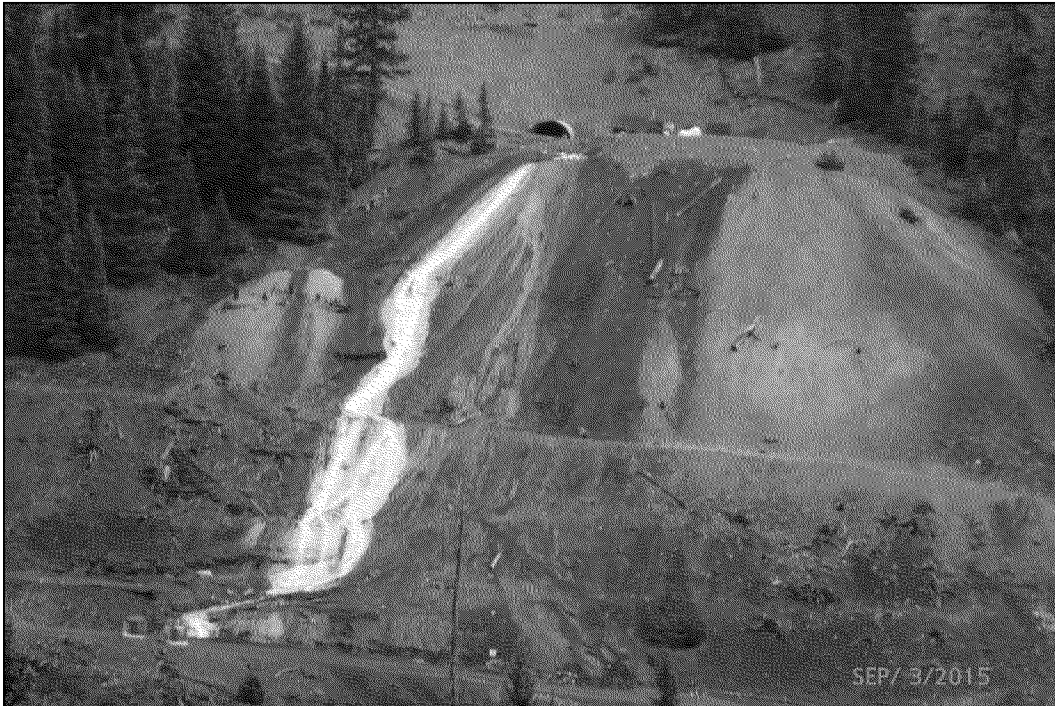
Figure 11.—Photograph showing acid drainage flowing out of the Red and Bonita Mine on September 3, 2015.

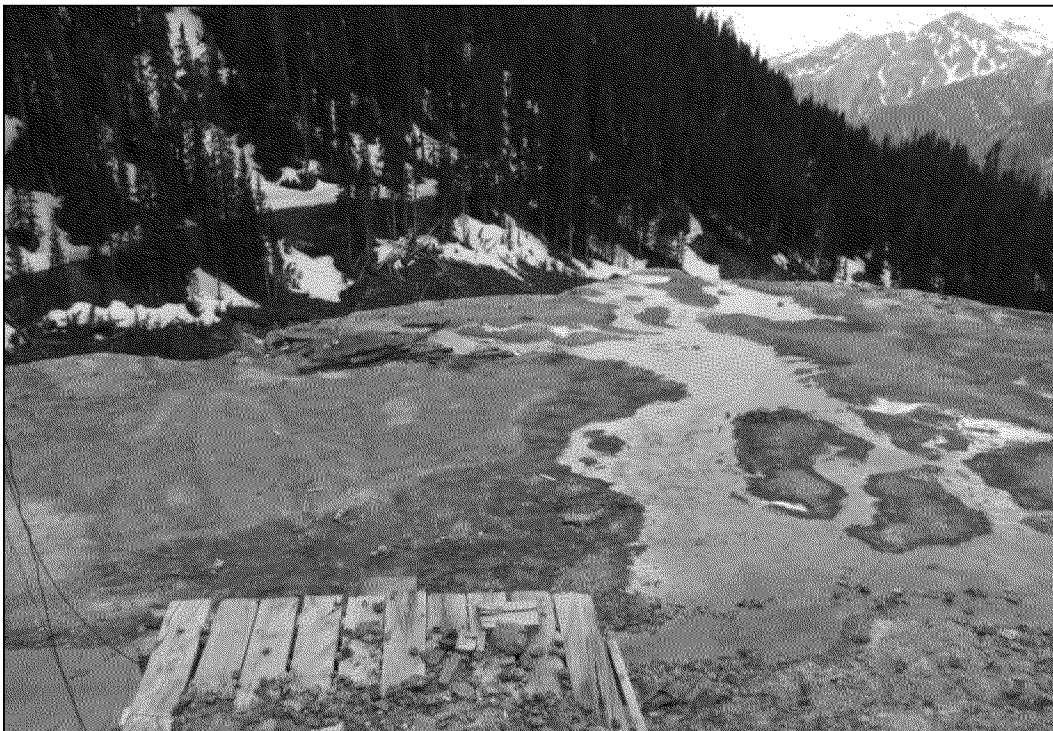
After the installation of a bulkhead in the Sunnyside Mine in 1996, seepage discharge from the Gold King Mine Level 7 New Adit portal showed a significant increase. The mining company holding the permit piped acid drainage from the Gold King Mine to Gladstone and operated the water treatment facility that was formerly used to treat the American Tunnel flows. They eventually filed for bankruptcy and discontinued running the water treatment system. The DRMS imposed forfeiture of the M-1986-013 reclamation bond in 2007. That same year there was a slope failure of the Gold King Mine Level 7 waste-rock dump due to increased adit flow causing saturation of a portion of the waste-rock dump (figures 14 and 15).

Figure 14.—Photograph showing adit seepage infiltrating into the Gold King Mine Level 7 waste-rock dump in 2007 (from DRMS project files).

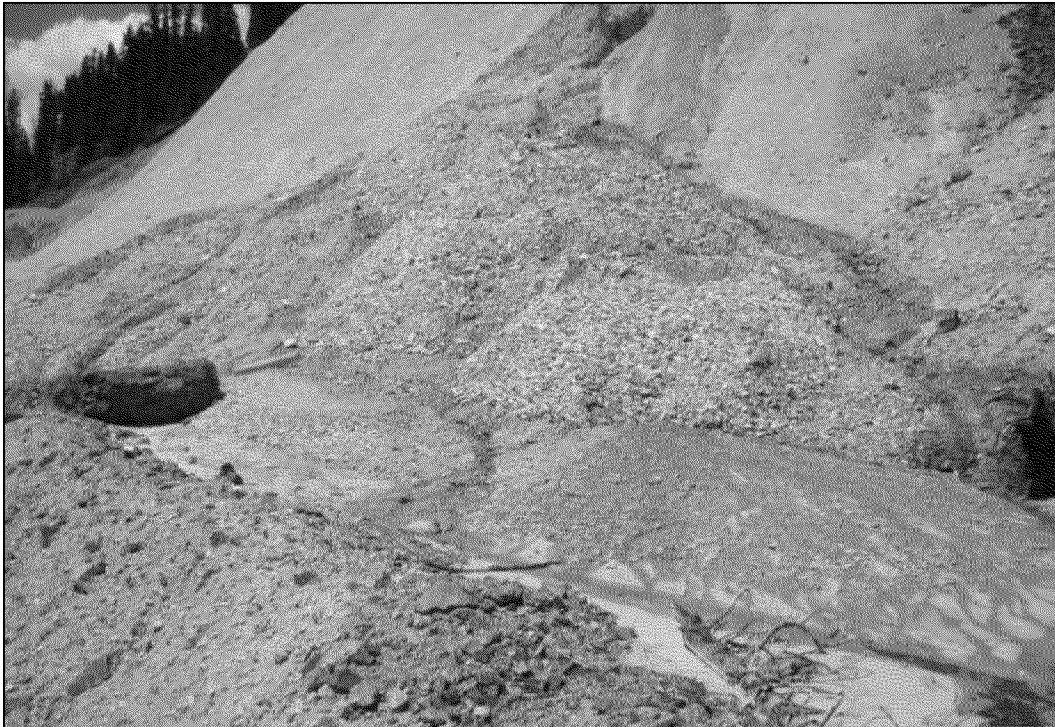
Figure 15.—Photograph showing deposition of landslide material in 2007 blocking a portion of the access road near the base of the waste-rock dump (from DRMS project files).

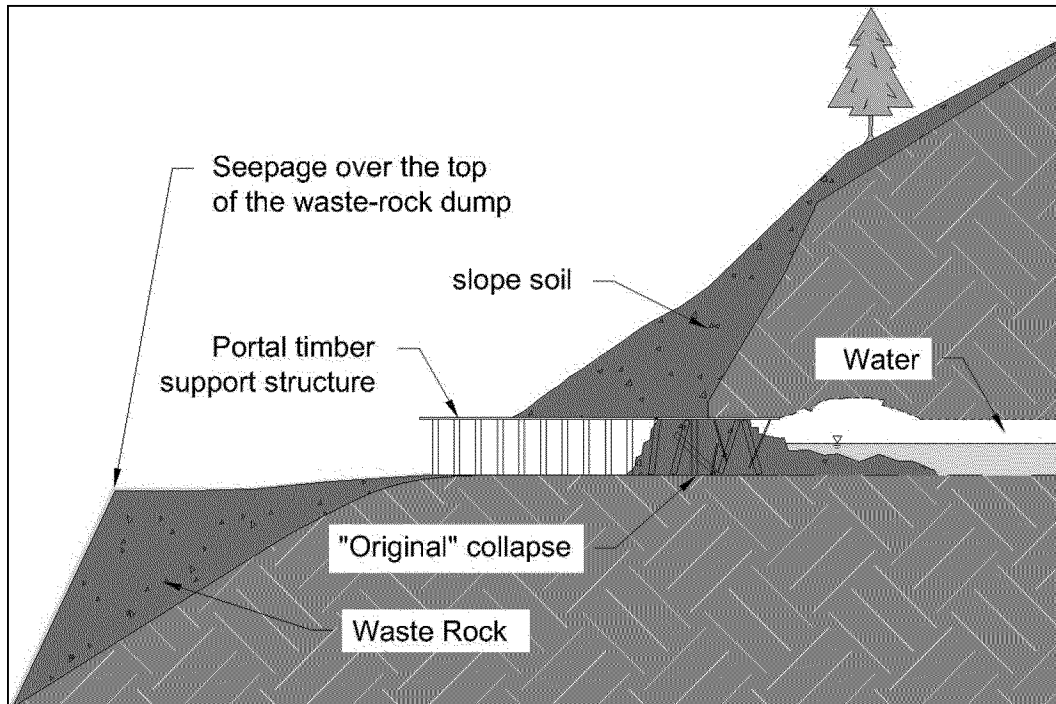
Figure 16.—Cross-section showing the condition of the Gold King Mine Level 7 New Adit in 2007 (not to scale). This shows the water level assumed by DRMS, but it may have been full of water at this time, as was later discovered.

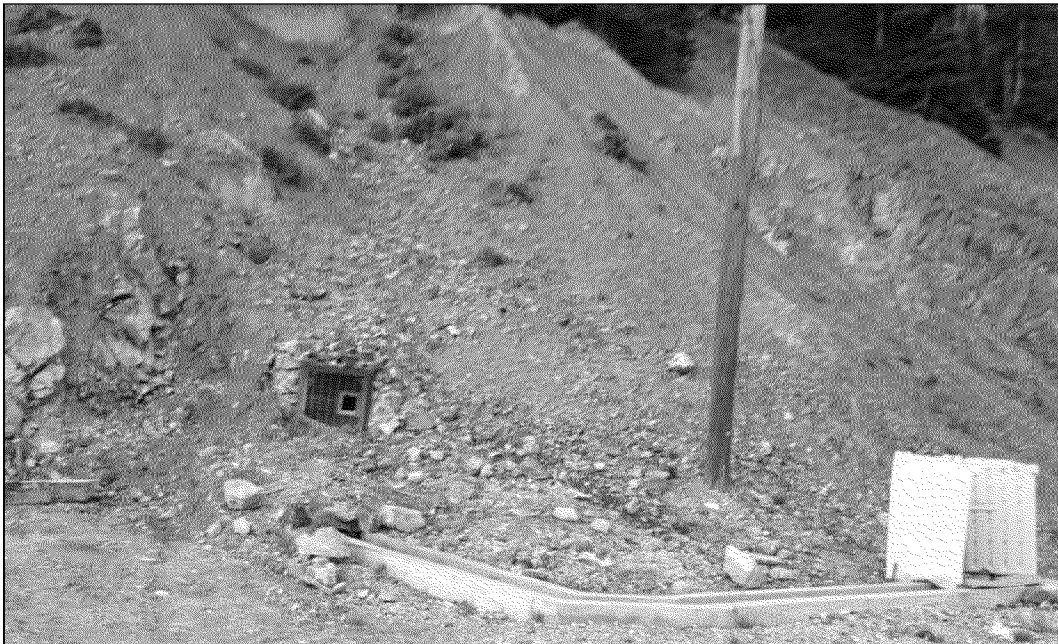
Figure 22.—Photograph showing the condition of the Gold King Level 7 New Adit portal on August 27, 2014, prior to any EPA modifications. Soil and rock debris have migrated downslope and covered a portion of the drain installed in 2009 (photograph from EPA project files).

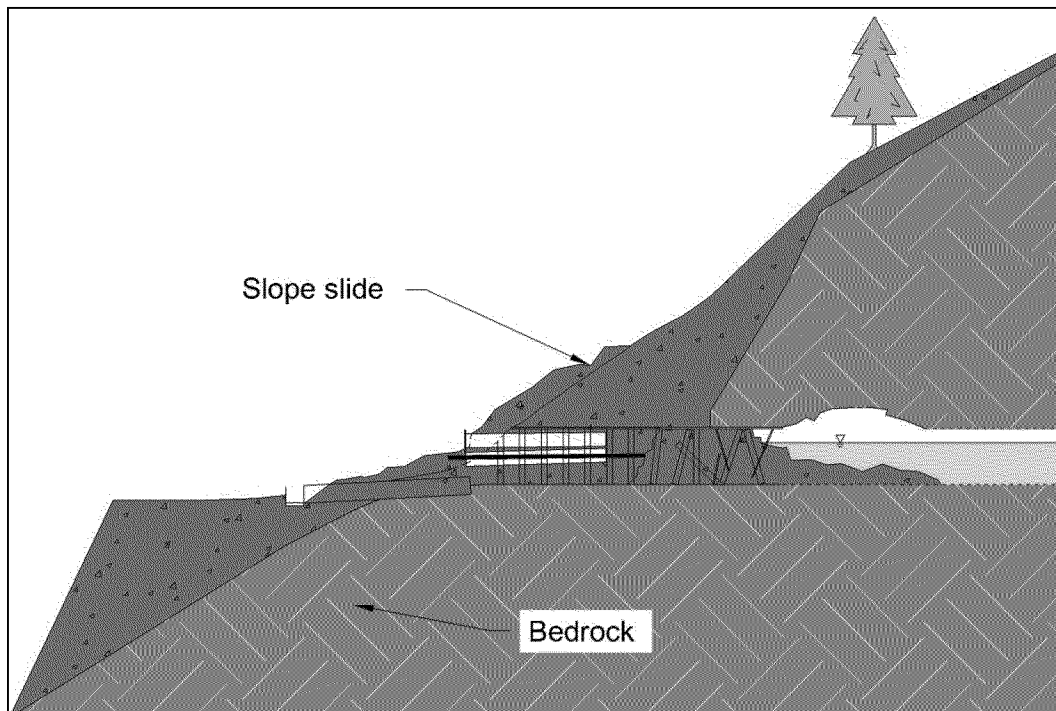
Figure 23.—Cross-section showing the condition of the Gold King Mine Level 7 New Adit in 2014 (water level as assumed by EPA and DRMS), more rock and soil had come down off the slope and were partially blocking the drain, which indicates a lack of maintenance (not to scale).

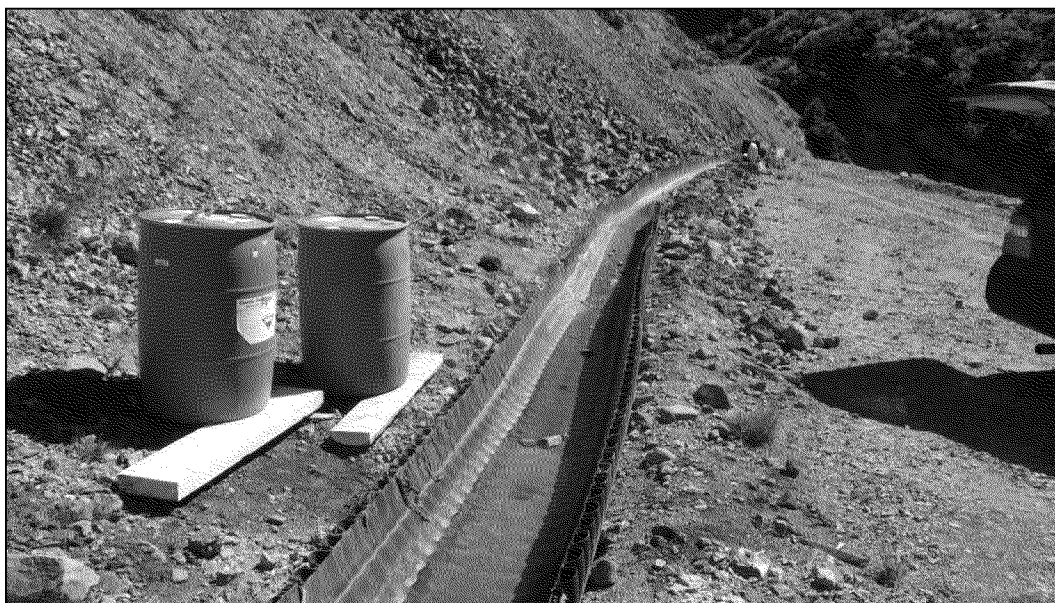
Figure 24.—Photograph showing seepage flow in the half-pipe channel at the Gold King Mine Level 7 New Adit area on September 11, 2014. Flow of approximately 12.6 gpm was recorded (photograph from EPA project files).

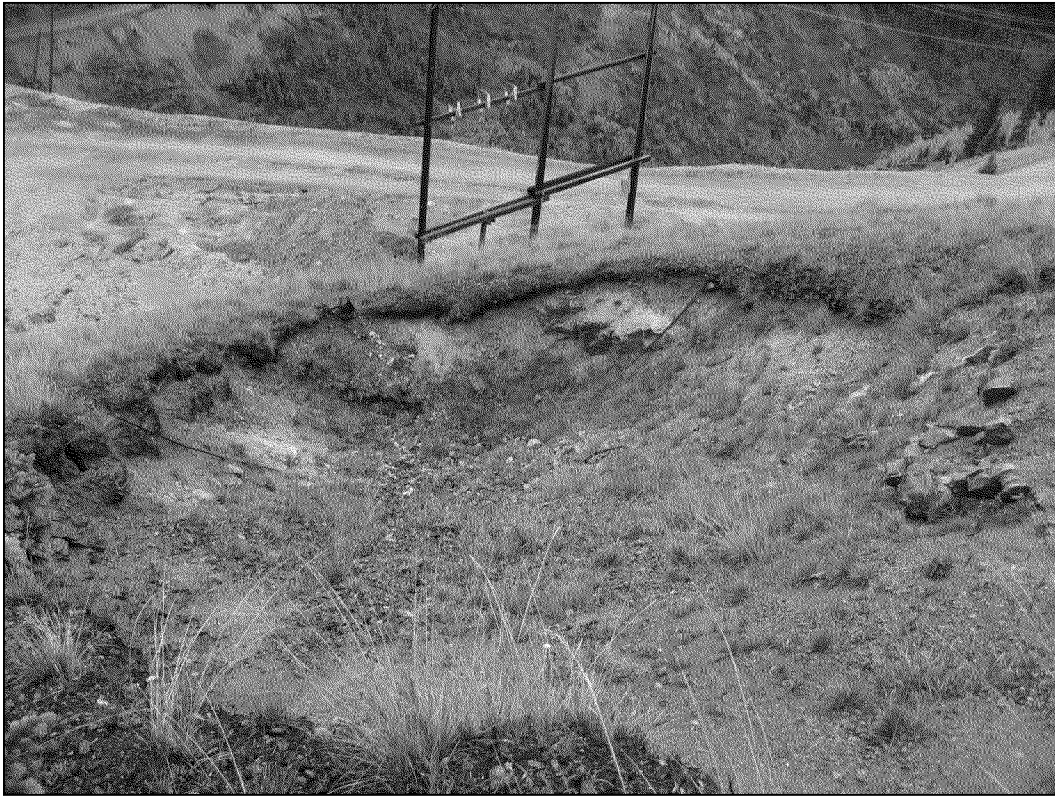
Figure 32.—Photograph taken on September 22, 2014, looking downhill at the subsidence pit located above the Gold King Mine Level 7 Old Adit.

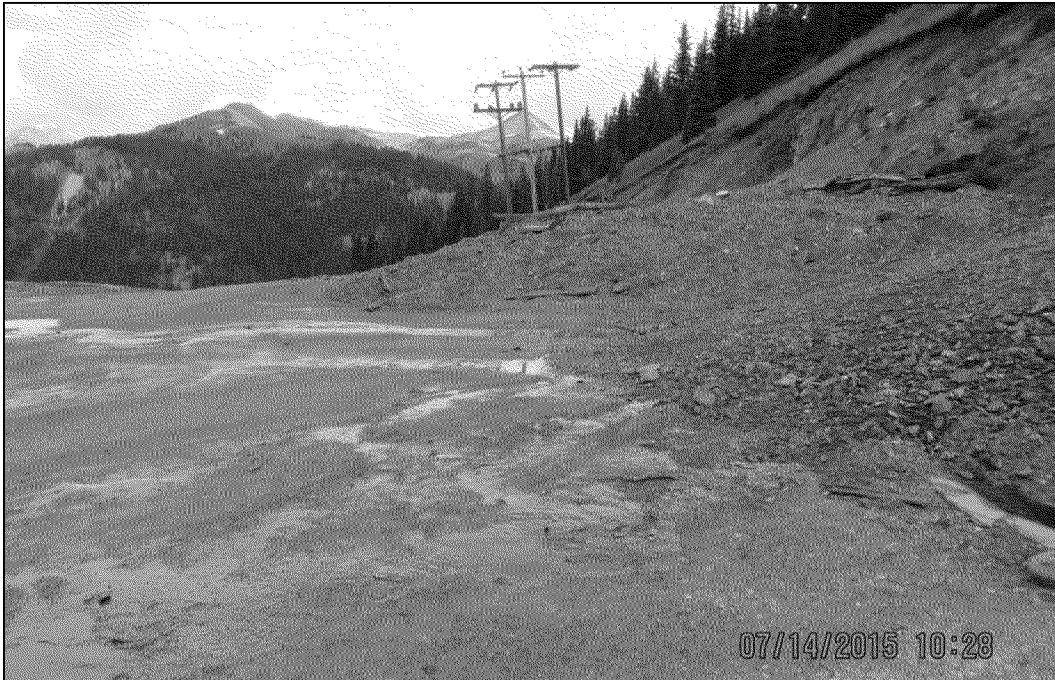
Figure 33.—Photograph showing the condition of the Gold King Mine Level 7 Old Adit portal area on July 14, 2015. Note that more soil and rock had slid from the slope area and had buried a portion of the concrete diversion channel including the ends of the two drain pipes (photograph from EPA project files).

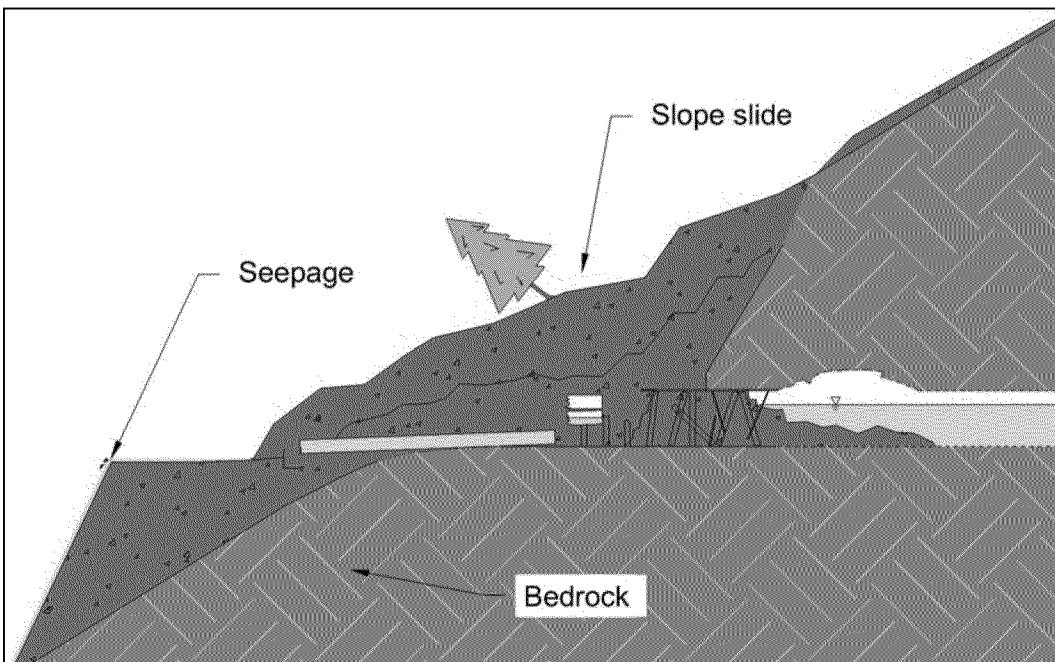
Figure 34.—Cross-section showing the condition of the Gold King Mine Old Adit on July 14, 2015 (water level as assumed by EPA and DRMS), when EPA returned to the site to begin work. More rock and soil and a tree had slid down onto the drains, and seepage was again saturating part of the waste-rock dump (not to scale).

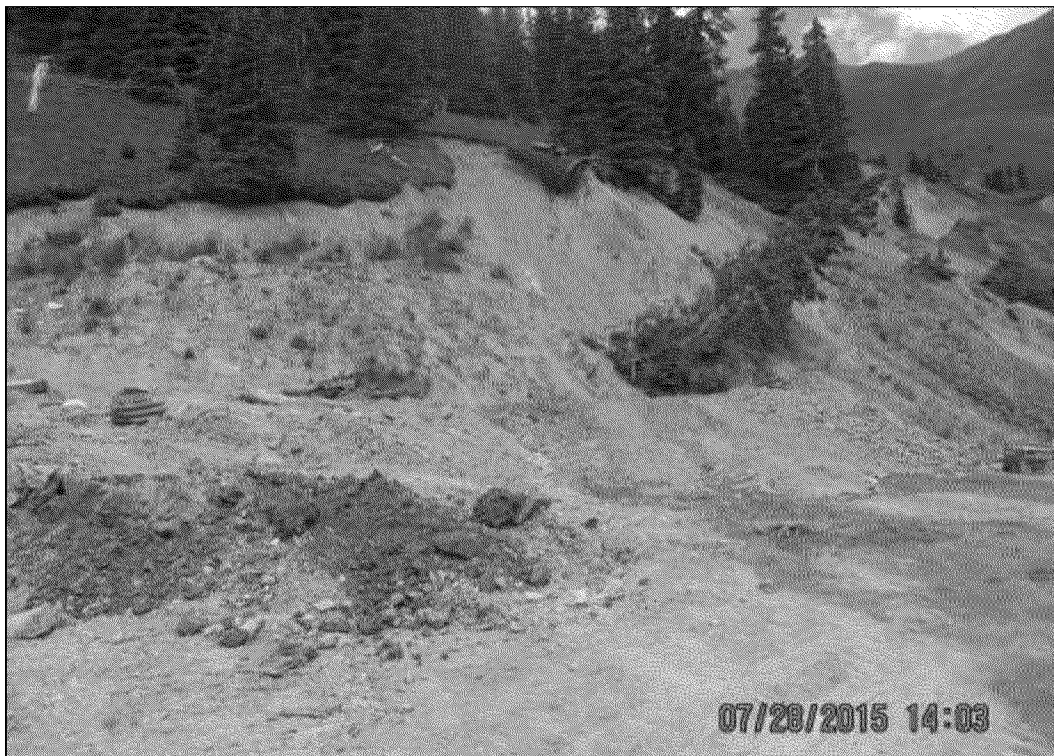
Figure 35.—Photograph showing the condition of the Gold King Mine Level 7 New Adit portal area on July 28, 2015. Note the soil and a tree that has slid downslope onto the portal area; at this time the seepage had been returned to the concrete trough, and the dump was drying out (photograph from EPA project files).

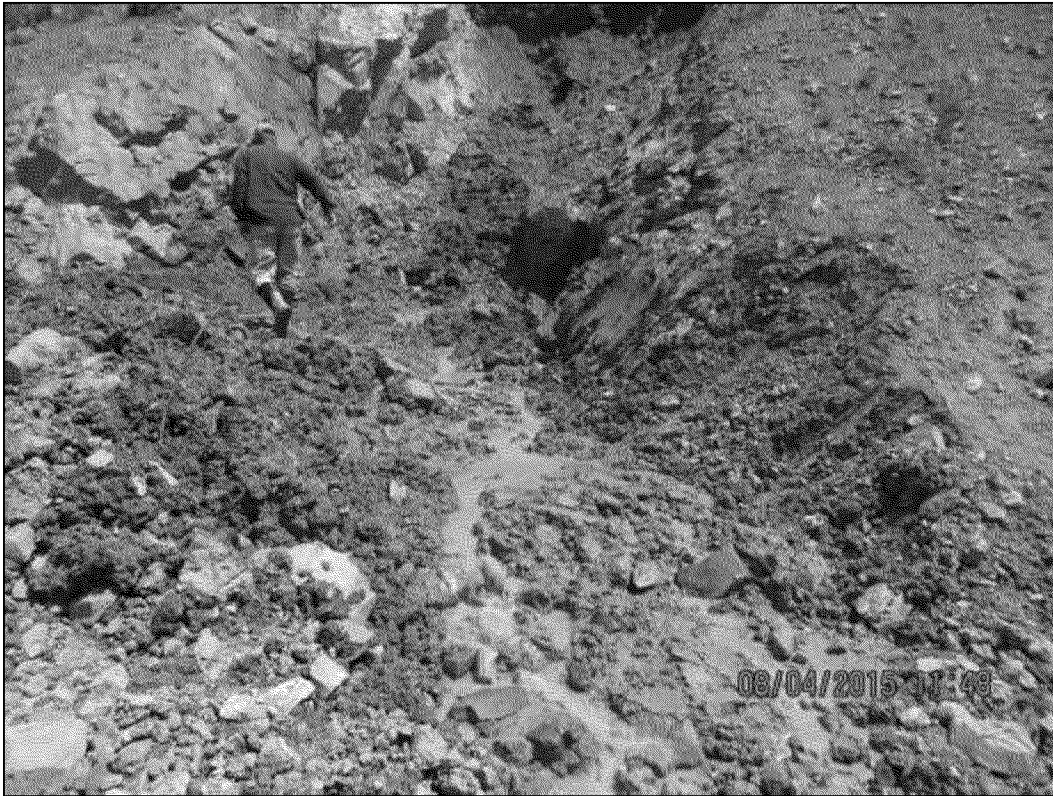
the downstream side of backfill placed at the portal. Adit seepage was observed in the downstream excavations to be emerging at an elevation about 6 feet above the adit floor. It was incorrectly concluded that the water level inside the mine was at a similar elevation, a few feet below the top of the adit roof. This error resulted in development of a plan to open the mine in a manner that appeared to guard against blowout, but instead led directly to the failure.

Figure 38.—Photograph showing seepage flow from the excavation at the Gold King Mine new portal at 11:48 a.m. on August 4, 2015. The flow is emerging approximately 5 to 6 feet above the floor of the adit (photograph from EPA project files).

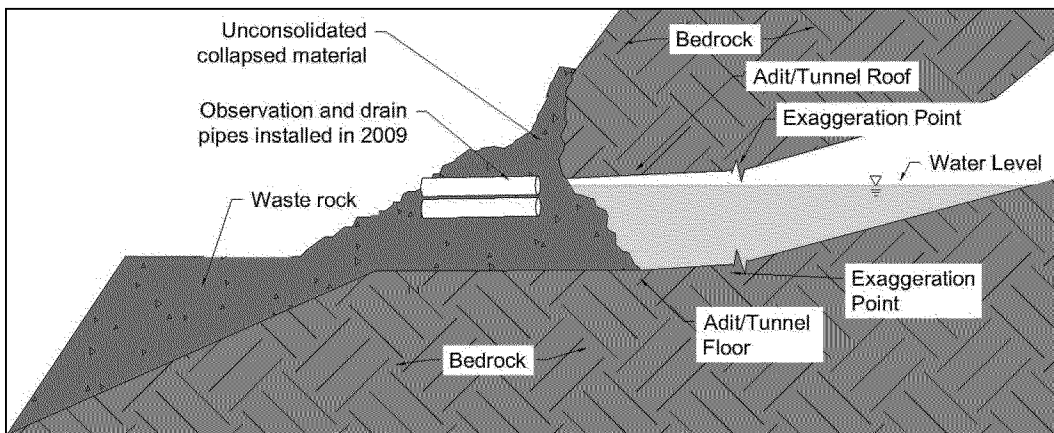
Figure 40.—Cross-section illustration showing the condition of the adit that was assumed by the EPA OSC and the abandoned mine experts from DRMS for use in planning to open the adit (not to scale). The “exaggeration point” means the right side of the drawing has an exaggerated vertical scale in order to show the 1% uphill slope of the adit. If drawn without exaggeration, the uphill slope of the adit would not be obvious on the drawing.

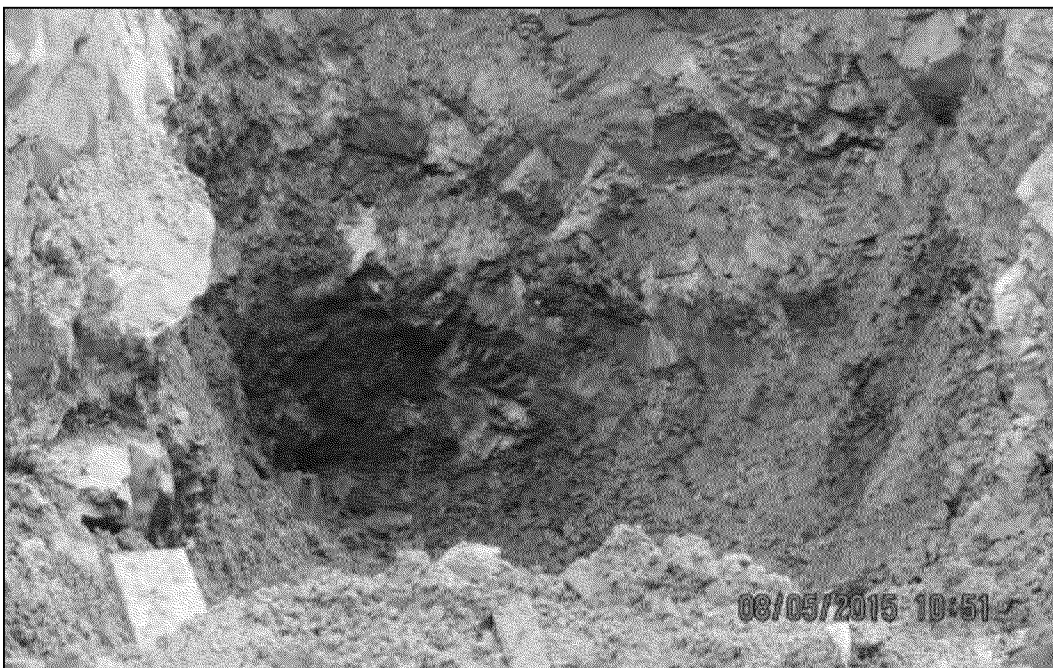
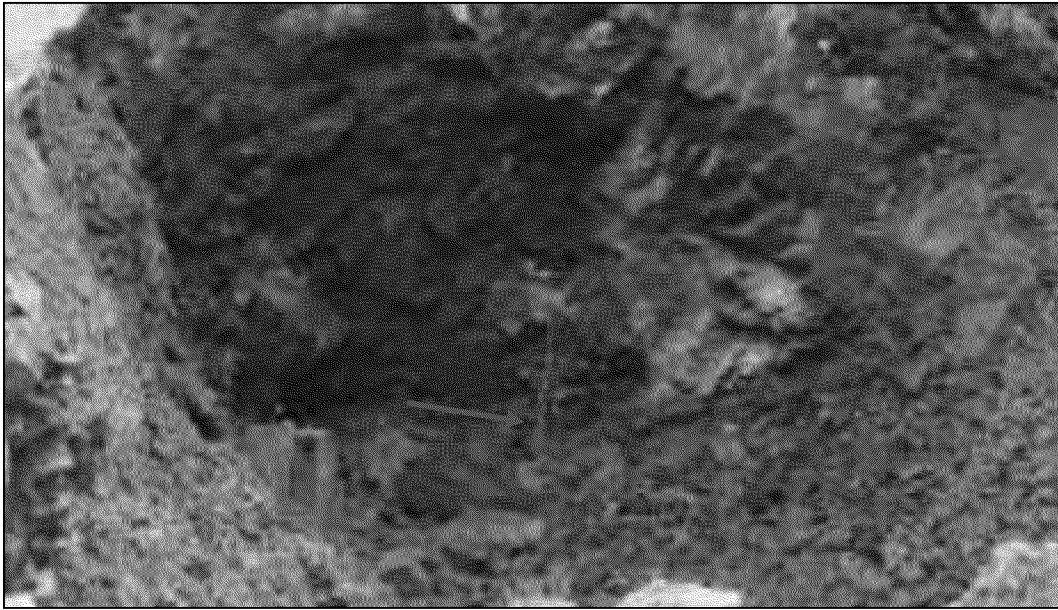
Figure 48.—Photograph taken at 10:51 a.m. on August 5, 2015, showing the initial spurt of clear water (photograph from EPA project files). The center of this photograph is shown enlarged in figure 49.

Figure 49.—A cropped and enlarged version of a portion of the photograph taken at 10:51 a.m. on August 5, 2015 (figure 48). Red arrow points to the initial vertical spurt of clear water shooting up about 1.5 to 2 feet as described by the EPA OSC (photograph from EPA project files).

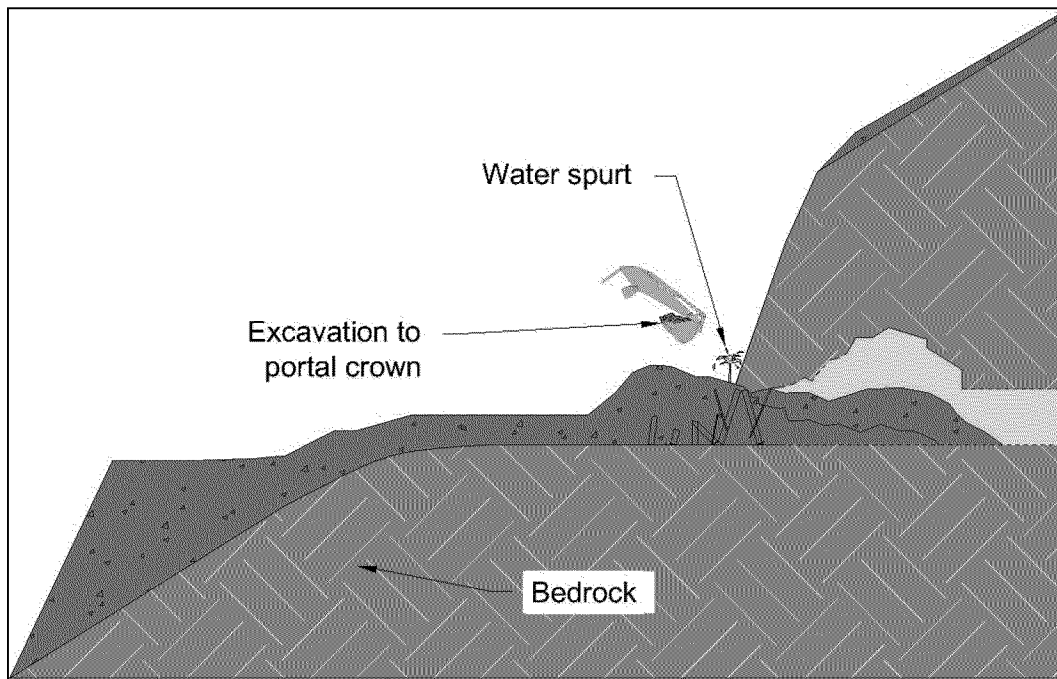
Figure 50.—Cross-section showing BOR's interpretation of the conditions immediately before the blowout as the spurt of water appeared indicating the adit was full and under pressure (not to scale).

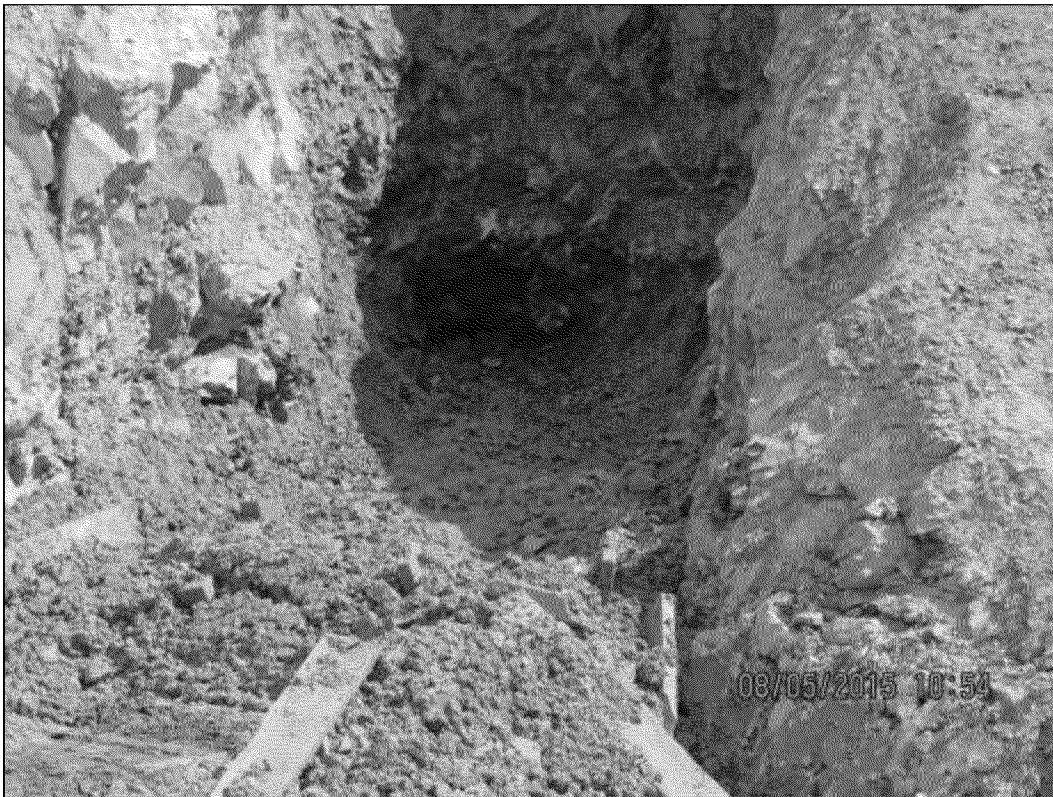
Figure 51.—Photograph of the uncontrolled flow taken at 10:54 a.m. on August 5, 2015. In 3 minutes, the flow progressed from a vertical spurt of water to the flow erosion evident in this photograph. The EPA OSC then made a decision to evacuate the portal opening to safeguard personnel onsite. A few moments later the flow erupted in an uncontrolled release (photograph from EPA project files).

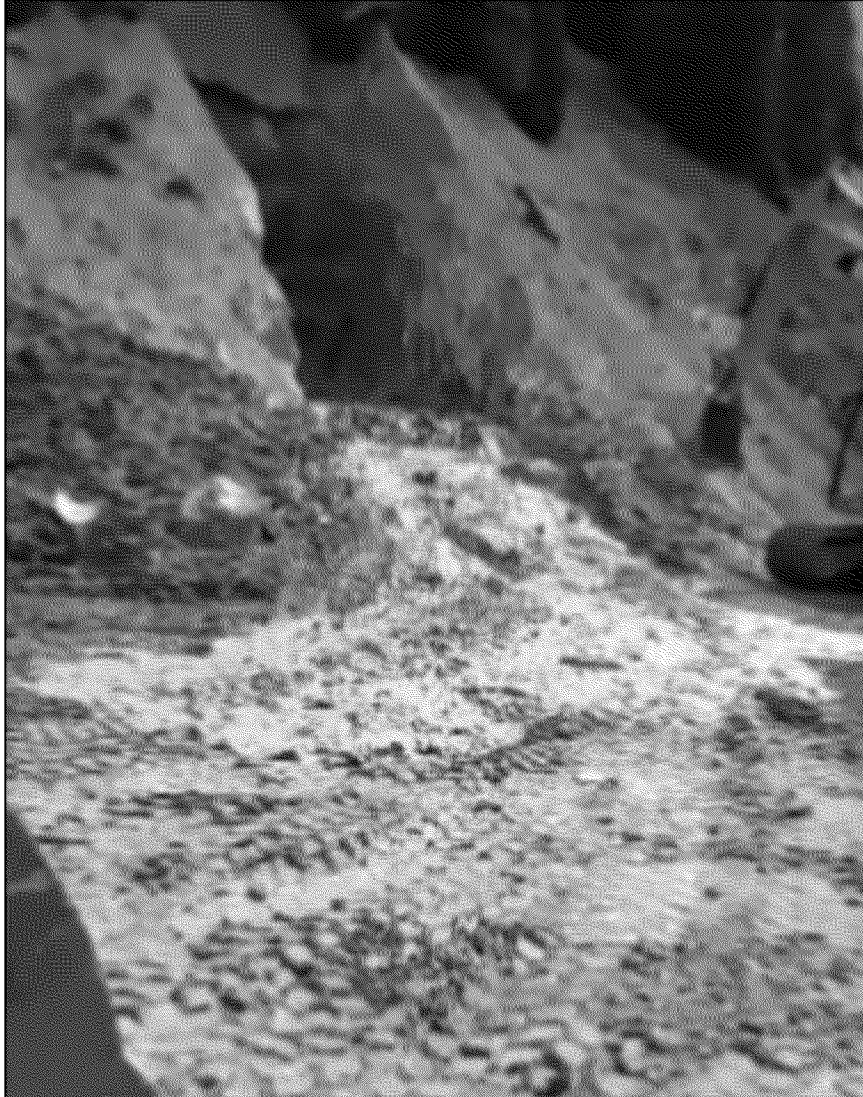
Figure 52.—Photograph showing the initial blowout from the adit. At this point, the flow is surging up over the backfill that was present in the portal area (still frame extracted from a video taken on August 5, 2015, at approximately 10:55 a.m.).

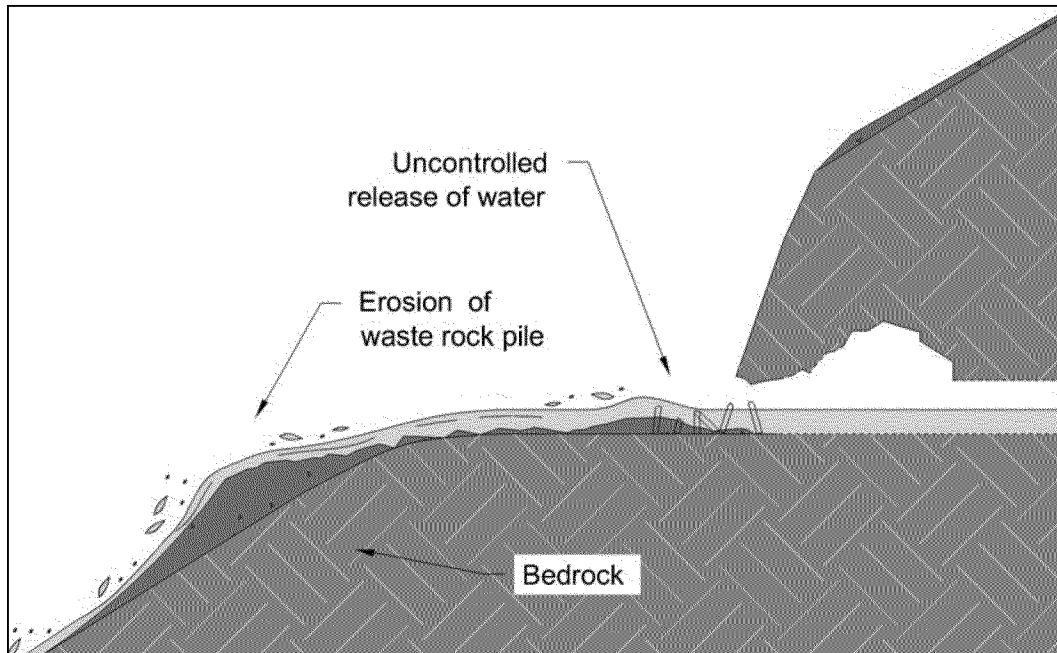
Figure 55.—Cross-section showing the blowout as it eroded the blockage and eroded fill from the waste-rock dump (not to scale).

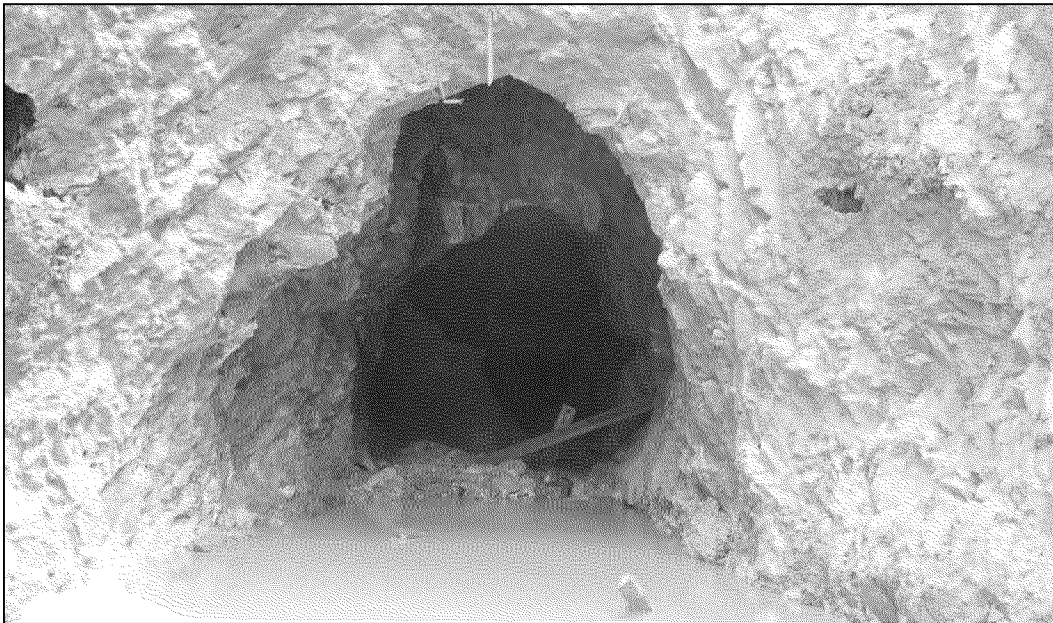
Figure 62.—Photograph showing the Gold King Mine Level 7 New Adit on August 16, 2015, after an excavator was used to reach inside the mine opening and remove the timbers. Note piles of debris from partial roof collapses inside the adit.

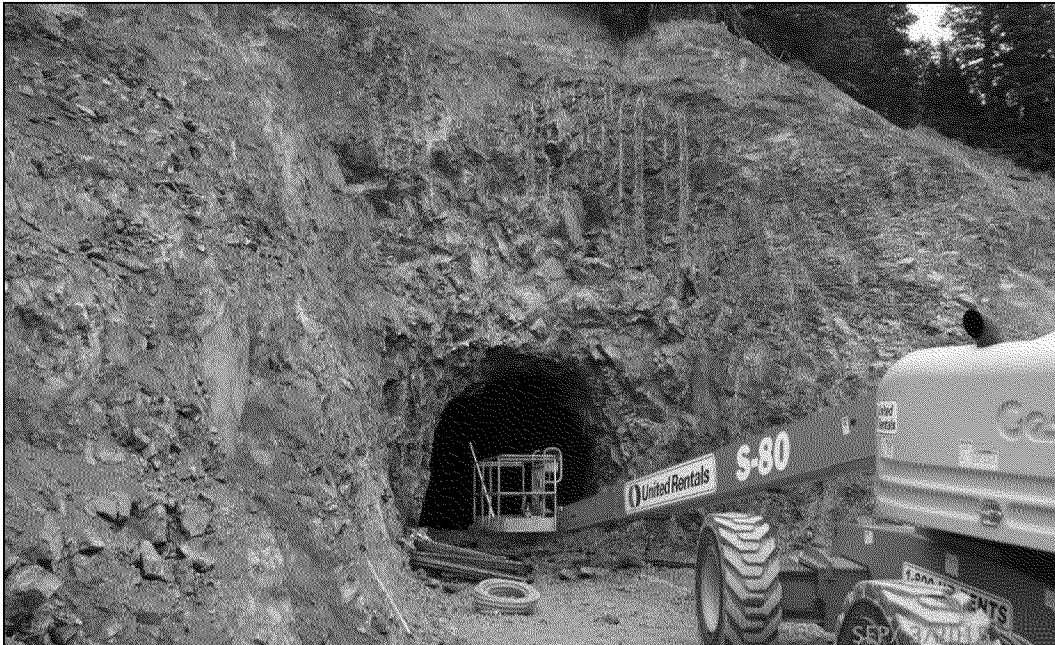
Figure 64.—Photograph showing the adit on September 3, 2015, at the initiation of rock bolting. The rock had been excavated to provide a larger work area. Note the excavator teeth marks left in the rock, an indication that the rock is altered and contains a significant amount of clay.
